**Flood Control Project Maintenance
Levee Inspections**
LMA District Cover Sheet
Spring 2018 Levee Inspection Results

Reclamation District No. 0017 Mossdale

Spring 2018 Levee Inspection Results

Waterway			Bank	Unit Miles
Unit No. 01 French Camp Slough			Left	1.76
	Spring (March - May)	Summer (June - August)	(September - November) Fall	Winter (December - February)
Unit Maintenance Rating (Fall Only)				
Date of Inspection	5/8/2018 - 5/8/2018			
DWR Inspector	Richard Willoughby			
Accompanied By	Richard Toy KSN			
	Scott Solari RD 17

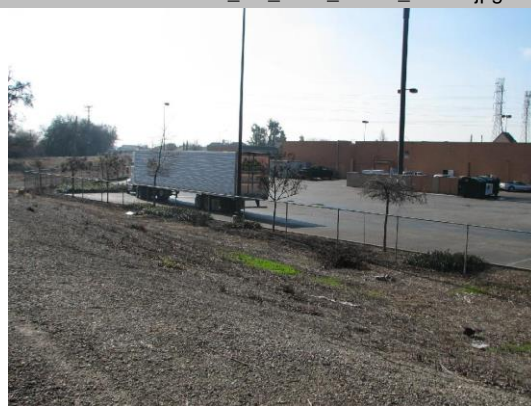
Photo 3 of 3 : UCIP_SP_2018_40603_38478.jpg

Comment Code						
Inspector Comment						
FS_ID:40603						
DS_ID:1						
EP_NO: 6623						
Repair Type: Non-Urgent						
Crossing Status: Found						
UCIP Comments: Marker missing on landward side. Need to contact owner to determine status of crossing. Need date of last inspection and confirmation that crossing is still in operable condition.						
FIELD_STRUCT_DESC: 5.563-inch welded steel natural gas pipeline through the levees, 4.5 feet below the crown, across the channels and overflow area. (5-inch gas line authorized under Permit No. 6623, 1969 - Laymac Corporation) [Additional Reference(s): DWR Levee Logs, 1981, 2003].						
FS Date: 2/3/2010

View of landward side.

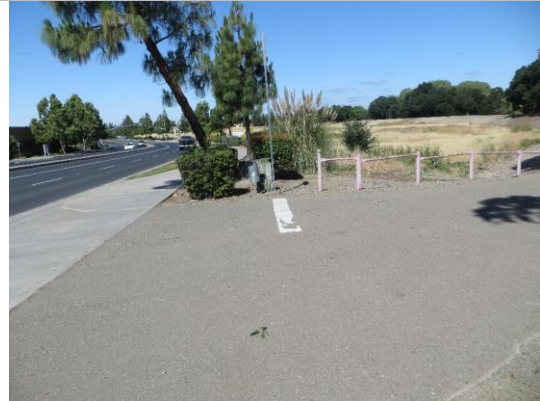
Photo 3 of 3 : UCIP_SP_2018_49990_74220.jpg

Comment Code						
Inspector Comment						
FS_ID:49990 DS_ID:72 EP_NO: 15185 Repair Type: Non-Urgent Crossing Status: Indicator Found UCIP Comments: 04/06/2018 Received supporting information from T. Marlow with KSN pertaining to line. PG&E has installed gas line distribution markers on both shoulder of the levee. Crossing is an active line. PG&E performs a leak survey at least twice a year according to Mr. R. Muok, Supervisor, Gas Pipeline Operations and Maintenance Stockton. Mr. Muok can be reached at 209-406-7926. Crossing has been downgraded from Urgent to Non-Urgent--pipe is inspected by owner. UCIP will need to coordinate with PG&E to obtain confirmation of inspections, obtain emergency contact information, and maintenance contact information. (DWR UCIP - O. Magana) 07/12/2016 No markers (no photos taken in 2016). Need to contact owner to determine status of crossing. If crossing is active, owner will need to coordinate with CVFPB to install markers to comply with Title 23. (DWR UCIP - omagana)5/19/2015 Need to install gasline markers. (DWR UCIP - omagana) FIELD_STRUCT_DESC: 8-inch soil proofed steel gas main through the left bank levee and under the channel of French Camp Slough. The pipeline has a minimum cover of 20 to 25 feet within the overflow areas and under the channel. (8-inch line authorized under Permit No. 15185, 1989 - Pacific Gas & Electric Company [PG&E]) FS Date: 7/12/2016

LS crown. No gasline markers.

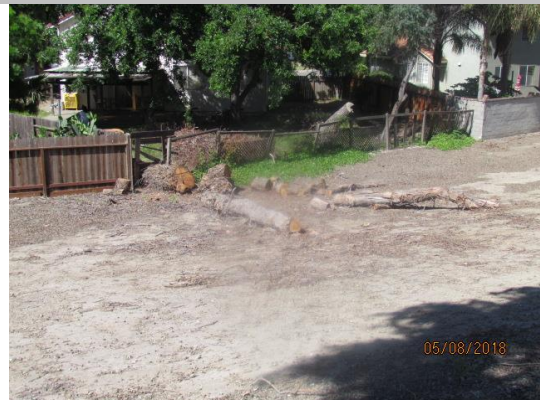
Photo 1 of 1 : SP_2018_RD0017_303_11_20180511_00017.jpg

LM Start	0.71	Rating **	M	Issue No.	11
LM End	0.71	Issue Type +	Ma	Location *	
Category	Earthen Levee			GPS Latitude/Longitude	
				Start	End
Item	Encroachments			37.914831 °	37.914831 °
				-121.301732 °	-121.301732 °
DWR ID	DWR_RD0017_01_s_2018_11				
Comment Code					
TR : Tree or limb					
Inspector Comment					
Fallen tree on landside slope and toe.

Looking west at tree limbs on landward slope and toe. (Spring 2018)

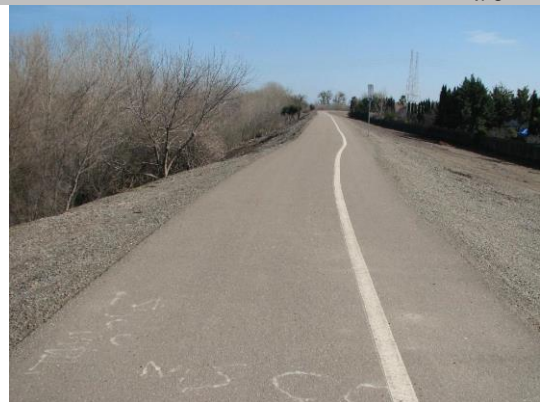
Photo 1 of 3 : UCIP_SP_2018_52614_38505.jpg

Comment Code						
Inspector Comment						
FS_ID:52614						
DS_ID:159						
EP_NO: 14992						
Repair Type: Non-Urgent						
Crossing Status: Indicator Found						
UCIP Comments: Need to contact owner to determine status of crossing. Also need date of last inspection.						
FIELD_STRUCT_DESC: [Weston Ranch - French Camp Slough Crossings] 2 of 3. 30-inch high-density polyethylene (HDPE) sewer force main (SFM) through the levee, 32 feet below levee crown. All pipes encased in concrete. (two 30-inch force mains (originally issued as 27-inch) and one 12-inch pipe authorized under Permit No. 14992, 1989 - City of Stockton and Richard Blewett) [Additional Reference(s): DWR Levee Logs, 1981, 2003]						
FS Date: 2/3/2010

Overview of levee at crossing.

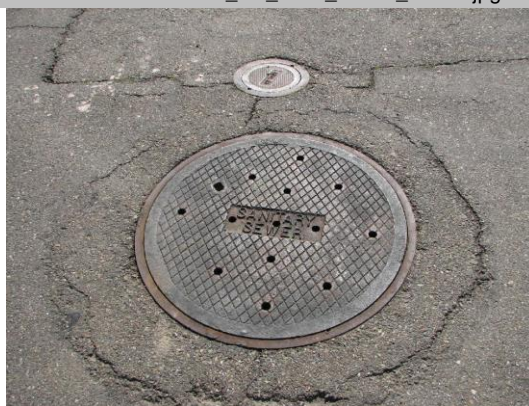
Photo 3 of 3 : UCIP_SP_2018_40606_71940.jpg

Comment Code						
Inspector Comment						
FS_ID:40606 DS_ID:158 EP_NO: 14992 Repair Type: Non-Urgent Crossing Status: Indicator Found UCIP Comments: Need to contact owner to determine status of crossing. Also need date of last inspection. FIELD_STRUCT_DESC: [Weston Ranch - French Camp Slough Crossings] 3 of 3. 12-inch high-density polyethylene (HDPE) sewer force main (SFM) through the levee, 32 feet below levee crown. All pipes encased in concrete. (two 30-inch force mains (originally issued as 27-inch) and one 12-inch pipe authorized under Permit No. 14992, 1989 - City of Stockton and Richard Blewett) [Additional Reference(s): DWR Levee Logs, 1981, 2003] FS Date: 2/3/2010

Manhole visible on landward side.

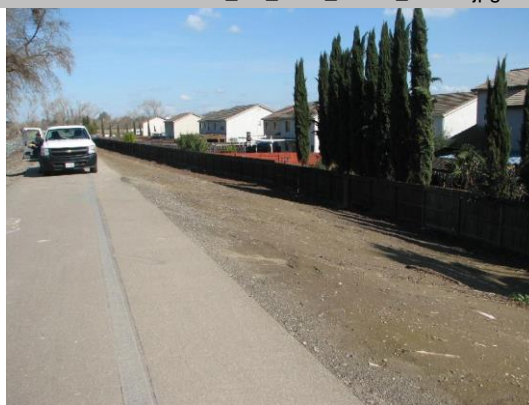
Photo 1 of 3 : UCIP_SP_2018_40628_38516.jpg

Comment Code					
Inspector Comment					
FS_ID:40628 DS_ID:75 EP_NO: 15093 Repair Type: Non-Urgent Crossing Status: Found UCIP Comments: Only appurtenances remaining at this location--4 pillings located on waterward side. According to records the pillings were to be removed under a completion maintenace contract. Need to coordinate with owner. FIELD_STRUCT_DESC: 14-inch-diameter pipeline through levee at unknown depth. Per inspector's notes "this crossing is abandoned almost all materials removed including pipes, conduit, and pump house. The only items left are 4 pilings which are to be removed under a completion maintenance contract. Approximately 200 feet of reinforced concrete pipe lateral removed in R/W south of crossing". FS Date: 2/3/2010

View of landward side.

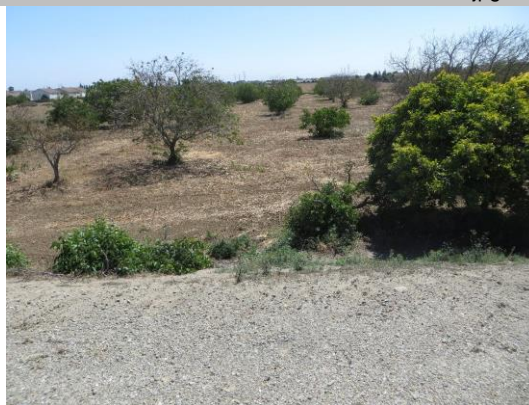
Photo 2 of 2 : UCIP_SP_2018_45449_74104.jpg

LM Start	1.18	Rating **	M	Issue No.	89	
LM End	1.18	Issue Type +	En	Location *		
Category	Supplemental			GPS Latitude/Longitude		
				Start	End	
Item	DWR UCIP Field Study			37.901012 °	37.901012 °	
				-121.325497 °	-121.325497 °	
DWR ID						
Comment Code						
Inspector Comment						
FS_ID:45449						
DS_ID:9						
EP_NO: N/A						
Repair Type: Non-Urgent						
Crossing Status: Indicator Found						
UCIP Comments: Appears abandoned. Should contact owner to determine status as signs have been removed from supports and should be replaced if still in service.						
FIELD_STRUCT_DESC: Underground telephone cable through levee, 2 feet below crown. Warning signs on waterside (WS) slope. [Additional Reference(s): DWR Levee Logs, 1981, 2003]						
FS Date: 5/19/2015

No markers on LS.

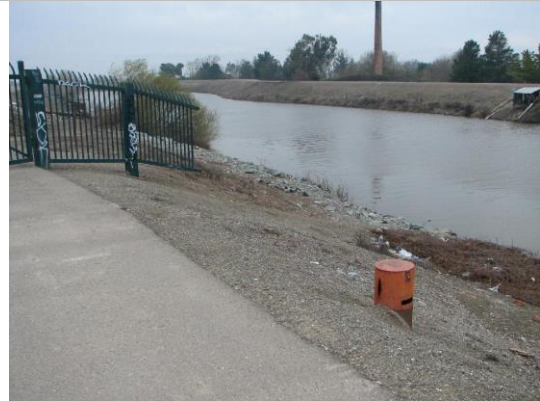
Photo 3 of 3 : UCIP_SP_2018_40639_38685.jpg

Siphon breaker located on waterward slope.

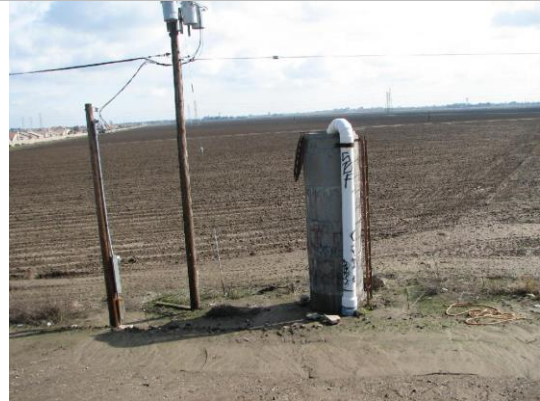
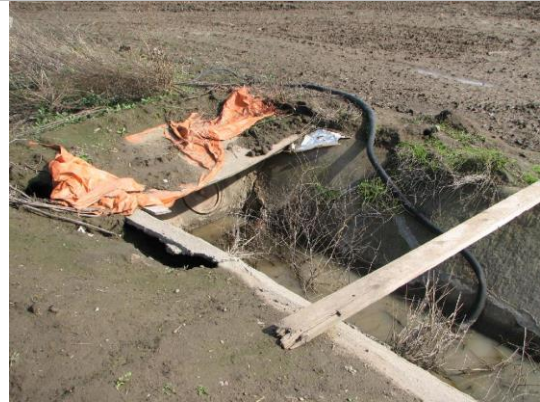
Concrete irrigation canal located at landward toe just upstream of crossing.

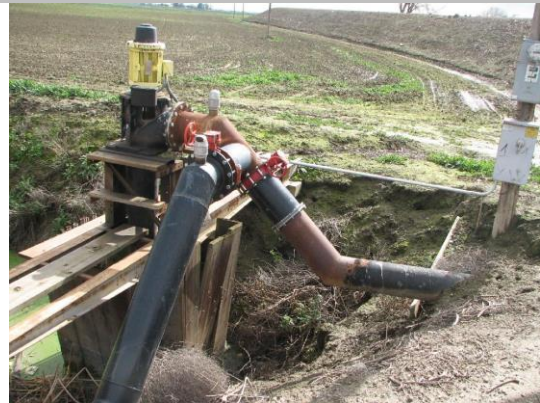
Photo 3 of 3 : UCIP_SP_2018_49640_74432.jpg

Pump, vent, butterfly valve, and pipe visible off LS toe.

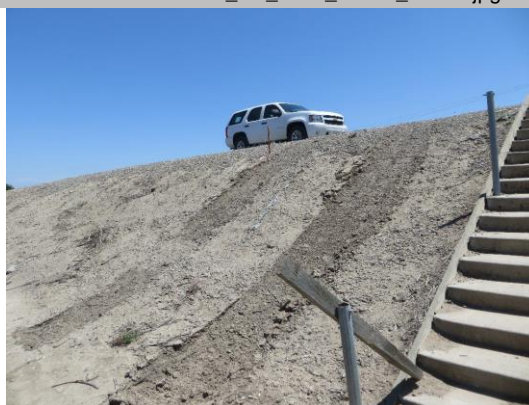
Photo 2 of 3 : UCIP_SP_2018_46009_74441.jpg

(2015) View of waterward slope--pipe removed.

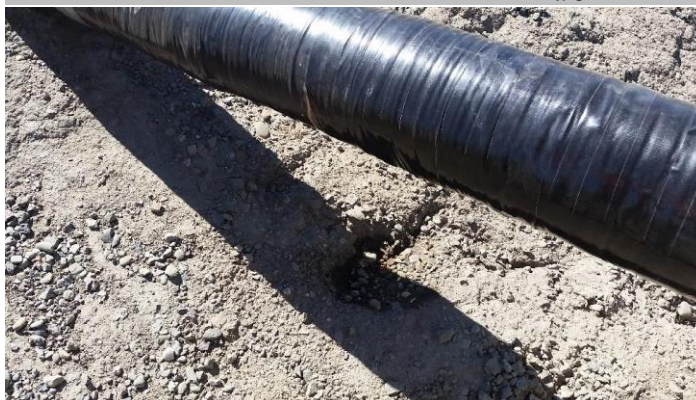
Photo 2 of 3 : UCIP_SP_2018_50081_75742.jpg

WS view--moisture observed on ground below wrapped pipe section, photo 1 of 2.

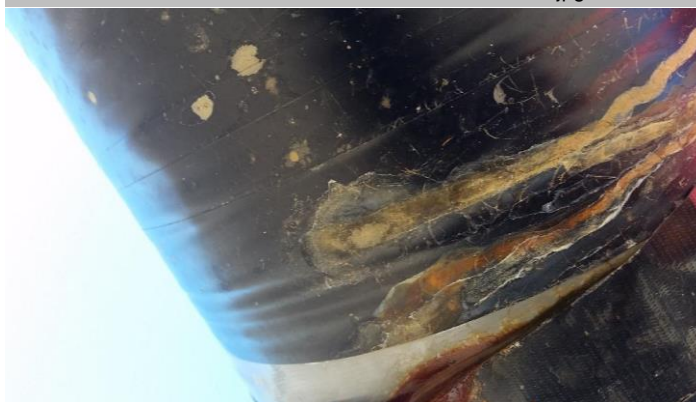
Photo 3 of 3 : UCIP_SP_2018_50081_75743.jpg

Pipe leak visible on WS pipe section, photo 2 of 2.

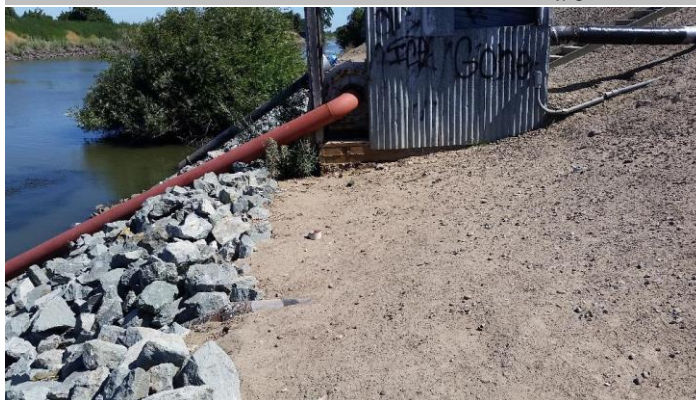
Photo 3 of 3 : UCIP_SP_2018_49993_75734.jpg

WS-pipe daylight just above rip rap near red pipe.

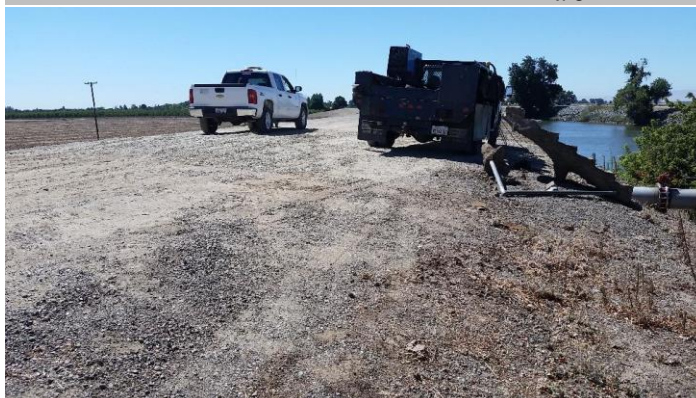
Photo 3 of 3 : UCIP_SP_2018_50004_75872.jpg

View of levee crown--construction on LS and WS in progress.

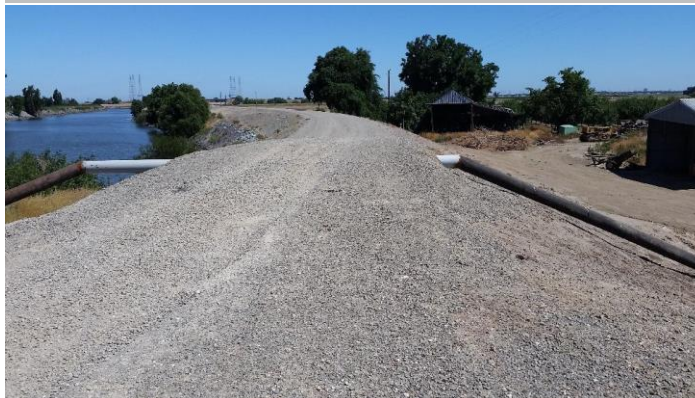
Photo 3 of 3 : UCIP_SP_2018_50005_75865.jpg

View of levee crown--levee section where pipe crosses is raised.

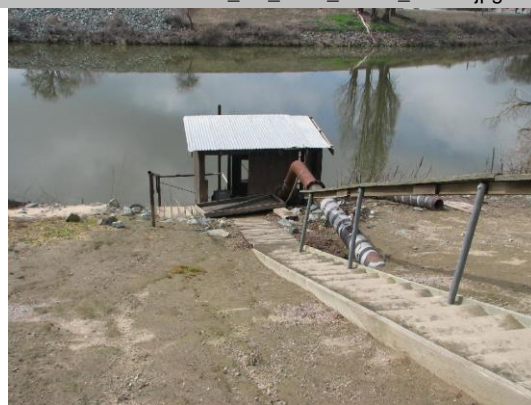
Photo 2 of 3 : UCIP_SP_2018_40662_72128.jpg

View of waterward side--pump house, walkway, pipe, and abandoned pipe section.

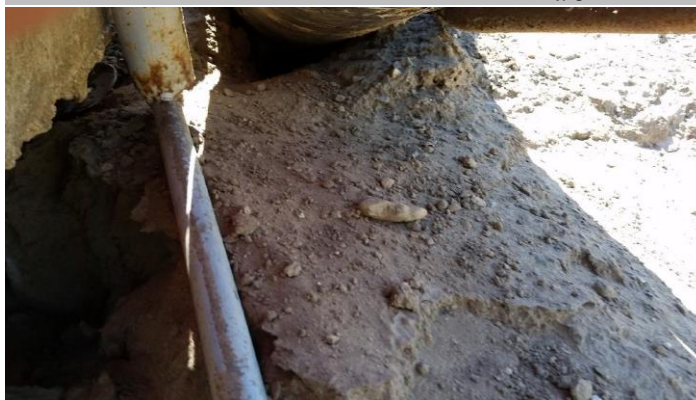
Photo 2 of 3 : UCIP_SP_2018_52574_75724.jpg

Internal erosion still visible on WS.

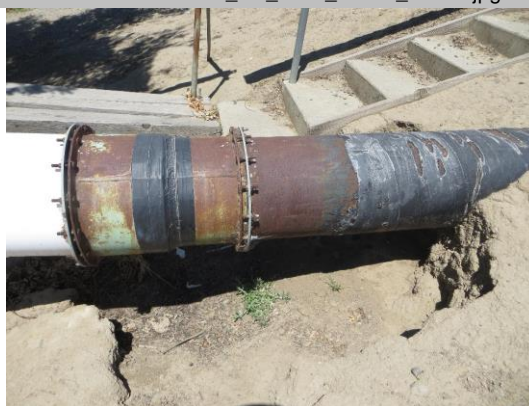
Photo 3 of 3 : UCIP_SP_2018_45998_74484.jpg

(2015) Erosion visible on waterward side.

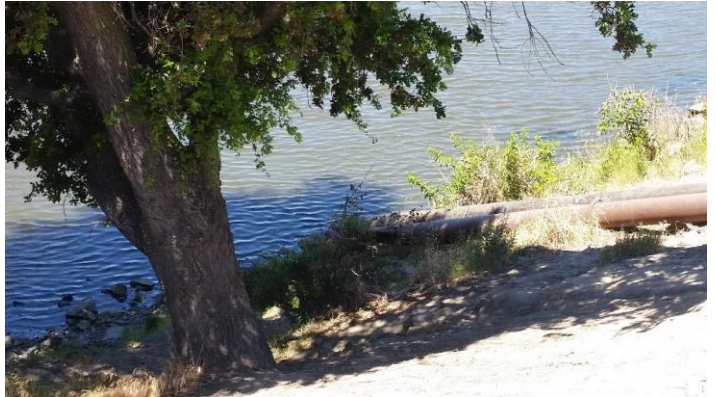
Photo 2 of 3 : UCIP_SP_2018_49999_75740.jpg

WS-pipe still damage, pipe wall section missing.

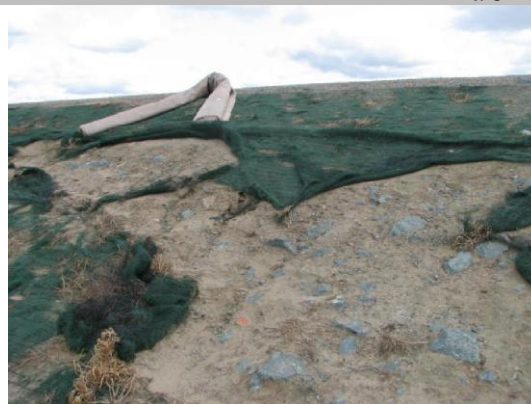
Photo 2 of 3 : UCIP_SP_2018_40697_72453.jpg

Geotech fabric damage along waterward berm.

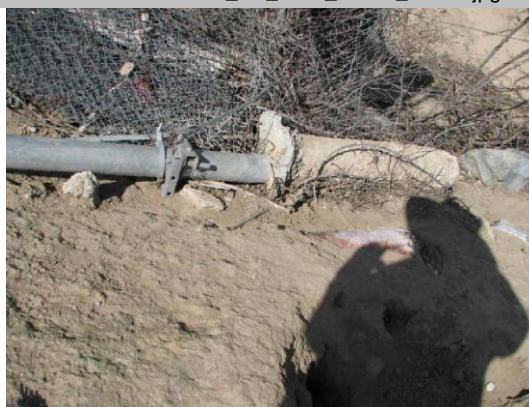
Photo 2 of 3 : UCIP_SP_2018_40712_72528.jpg

Pipe section exposed on landward side.

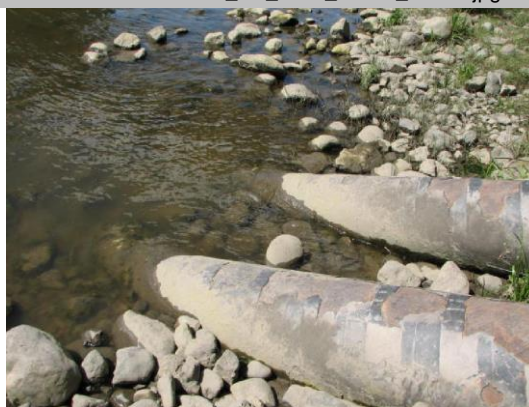
Photo 3 of 3 : UCIP_SP_2018_40713_72537.jpg

Sections of protective wrap missing near waterward toe.
